Debris/Ice/TPS Assessment And Photographic Analysis For Shuttle Mission STS-43

DEBRIS/ICE/TPS ASSESSMENT
AND
PHOTOGRAPHIC ANALYSIS
OF
SHUTTLE MISSION STS-43

August 2, 1991

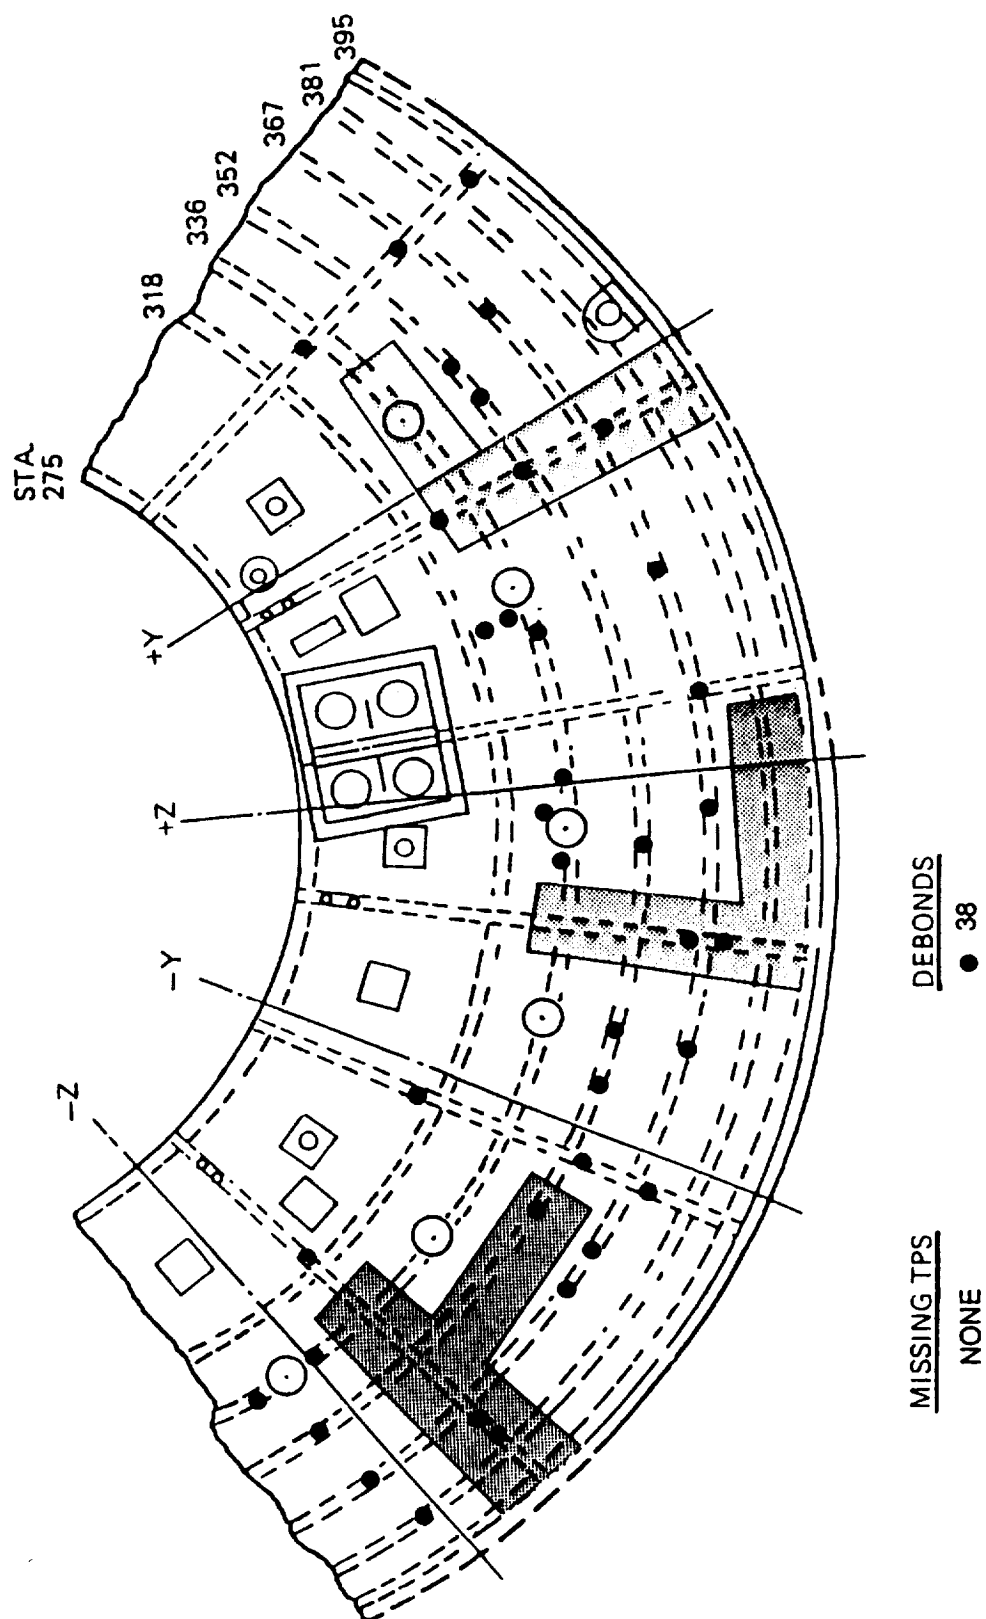
FIGURE 12. LEFT SRB FRUSTUM

The LH frustum exhibited no missing TPS but had 38 MSA-2 debonds over fasteners (Figure 12). Minor blistering of the Hypalon paint occurred at three locations. All BSM covers were locked in the fully opened position.

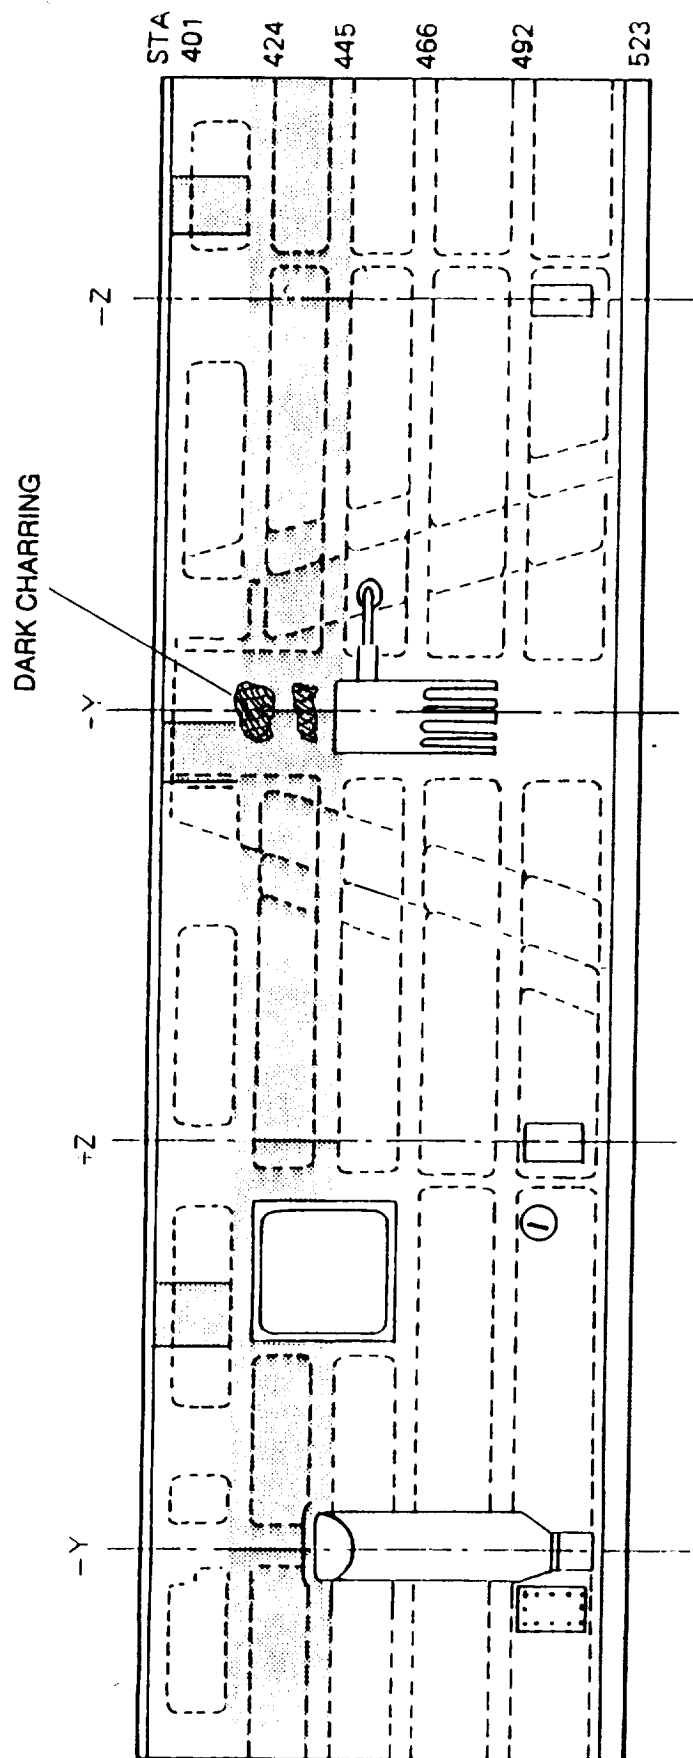
FIGURE 13.

The LH forward skirt exhibited no debonds. MSA-2, 2.5"x1" in size, was missing from an area one foot forward of the skirt clevis and one foot outboard of the +Z RSS antenna (aft of the flight door). The phenolic plates on both RSS antennae were intact. At least one layer of the phenolic plate on the +Z antenna was delaminated. The forward separation bolt and electrical cables appeared to have separated cleanly. No pins were missing from the frustum severance ring. Minor blistering of the Hypalon paint occurred forward of the ET/SRB attach point (Figure 13).

TPS MISSING
1. 2.5" X 1" PIECE

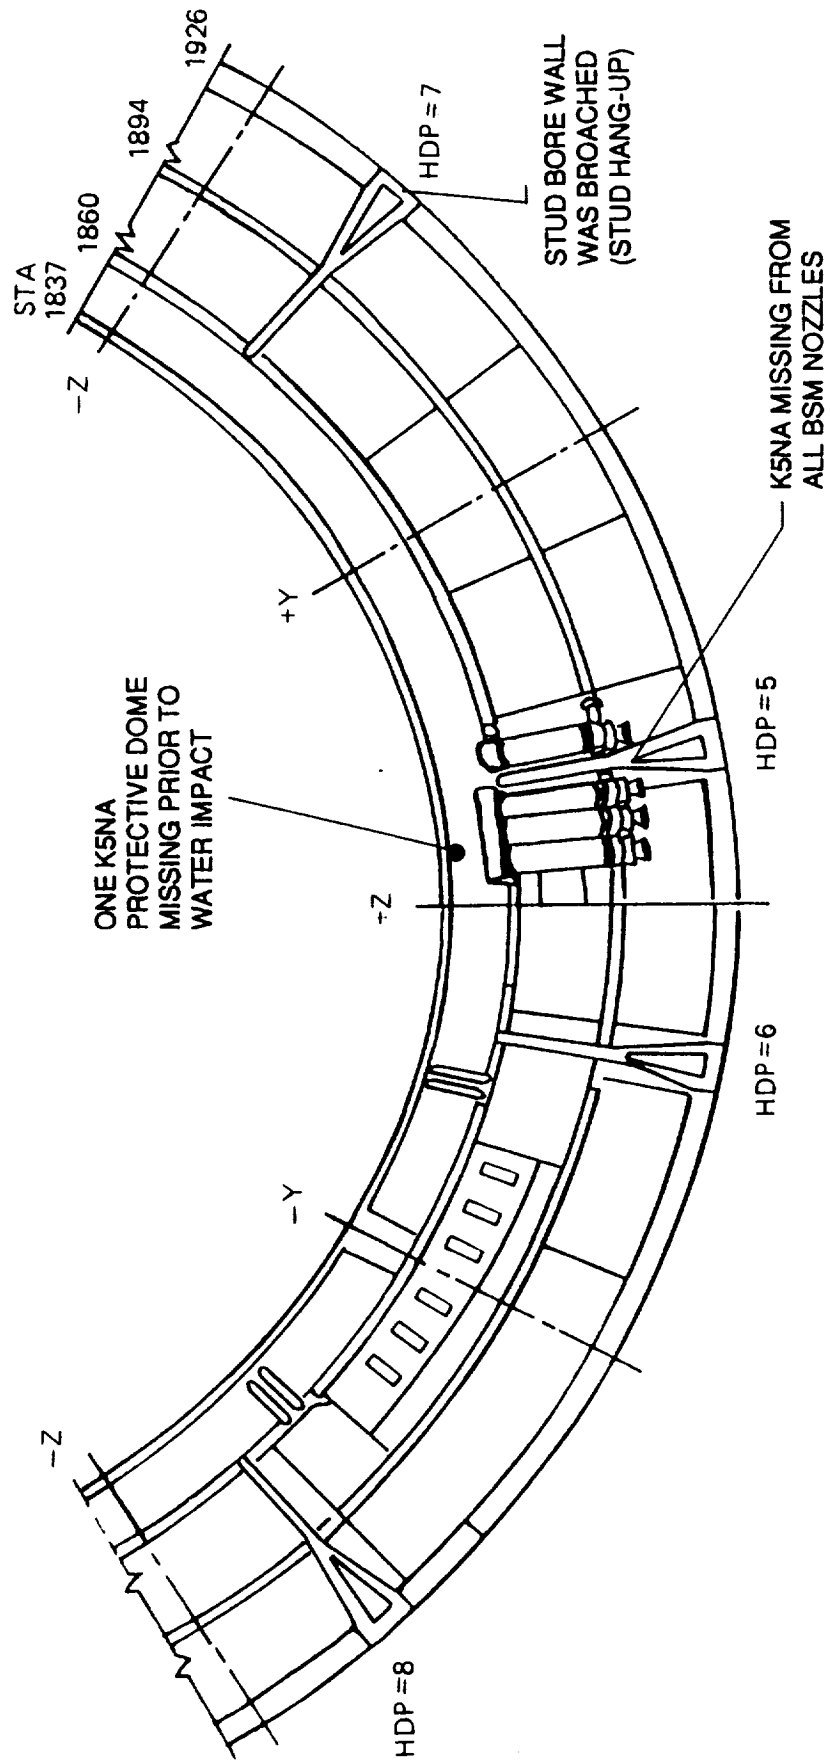
FIGURE 14.

The phenolic material on the kick ring delaminated at several locations. One K5NA protective dome was lost from a bolt head on the aft side of the phenolic kick ring near HDP #5 prior to water impact. The aft skirt acreage TPS was in good condition (Figure 14). K5NA was missing from all aft BSM nozzles.

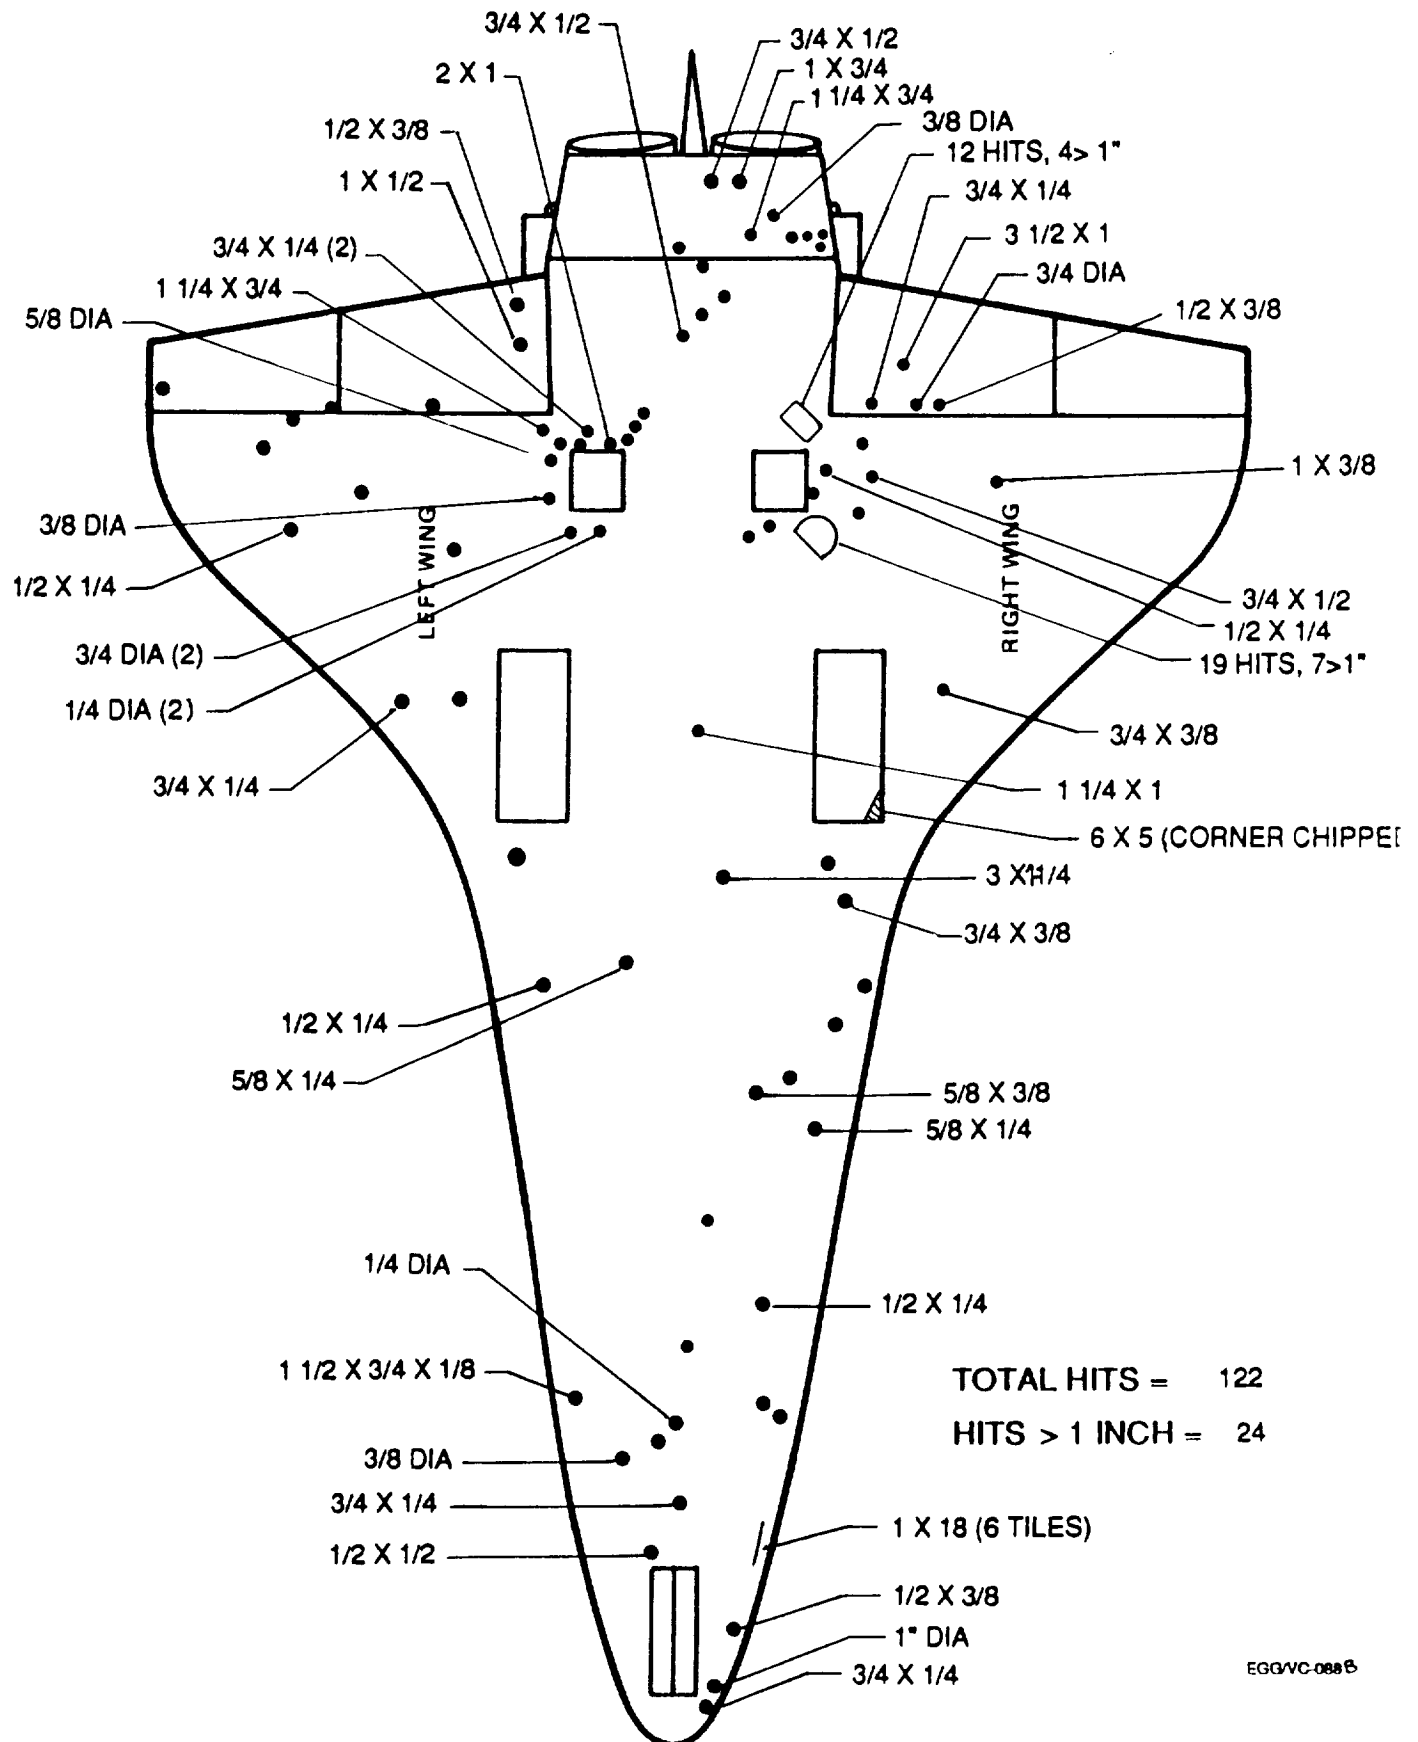
FIGURE 15. **STS-43**
DEBRIS DAMAGE LOCATIONS

The Orbiter lower surface had a total of 122 hits of which 24 had a major dimension of one inch or greater. A comparison of these numbers to statistics from 29 previous missions of similar configuration (excluding missions STS-24, 25, 26, 26R, 27R, and 30R which had damage from known debris sources), indicates both the total number of hits and the hits one inch or larger on the lower surface was greater than average. Figures 15 through 18 show the TPS damage locations for STS-43.

The largest single damage site on the Orbiter lower surface occurred on the RH nose area below the forward RCS module and measured approximately 18" x 1" x 1/8" (spanned 6 tiles). This shallow hit is indicative of damage typically caused by low density material, such as ET SOFI. Post-separation ET photographs taken by the crew (DTO-312) showed only the -Y side of the tank and could not confirm the loss of ET TPS.

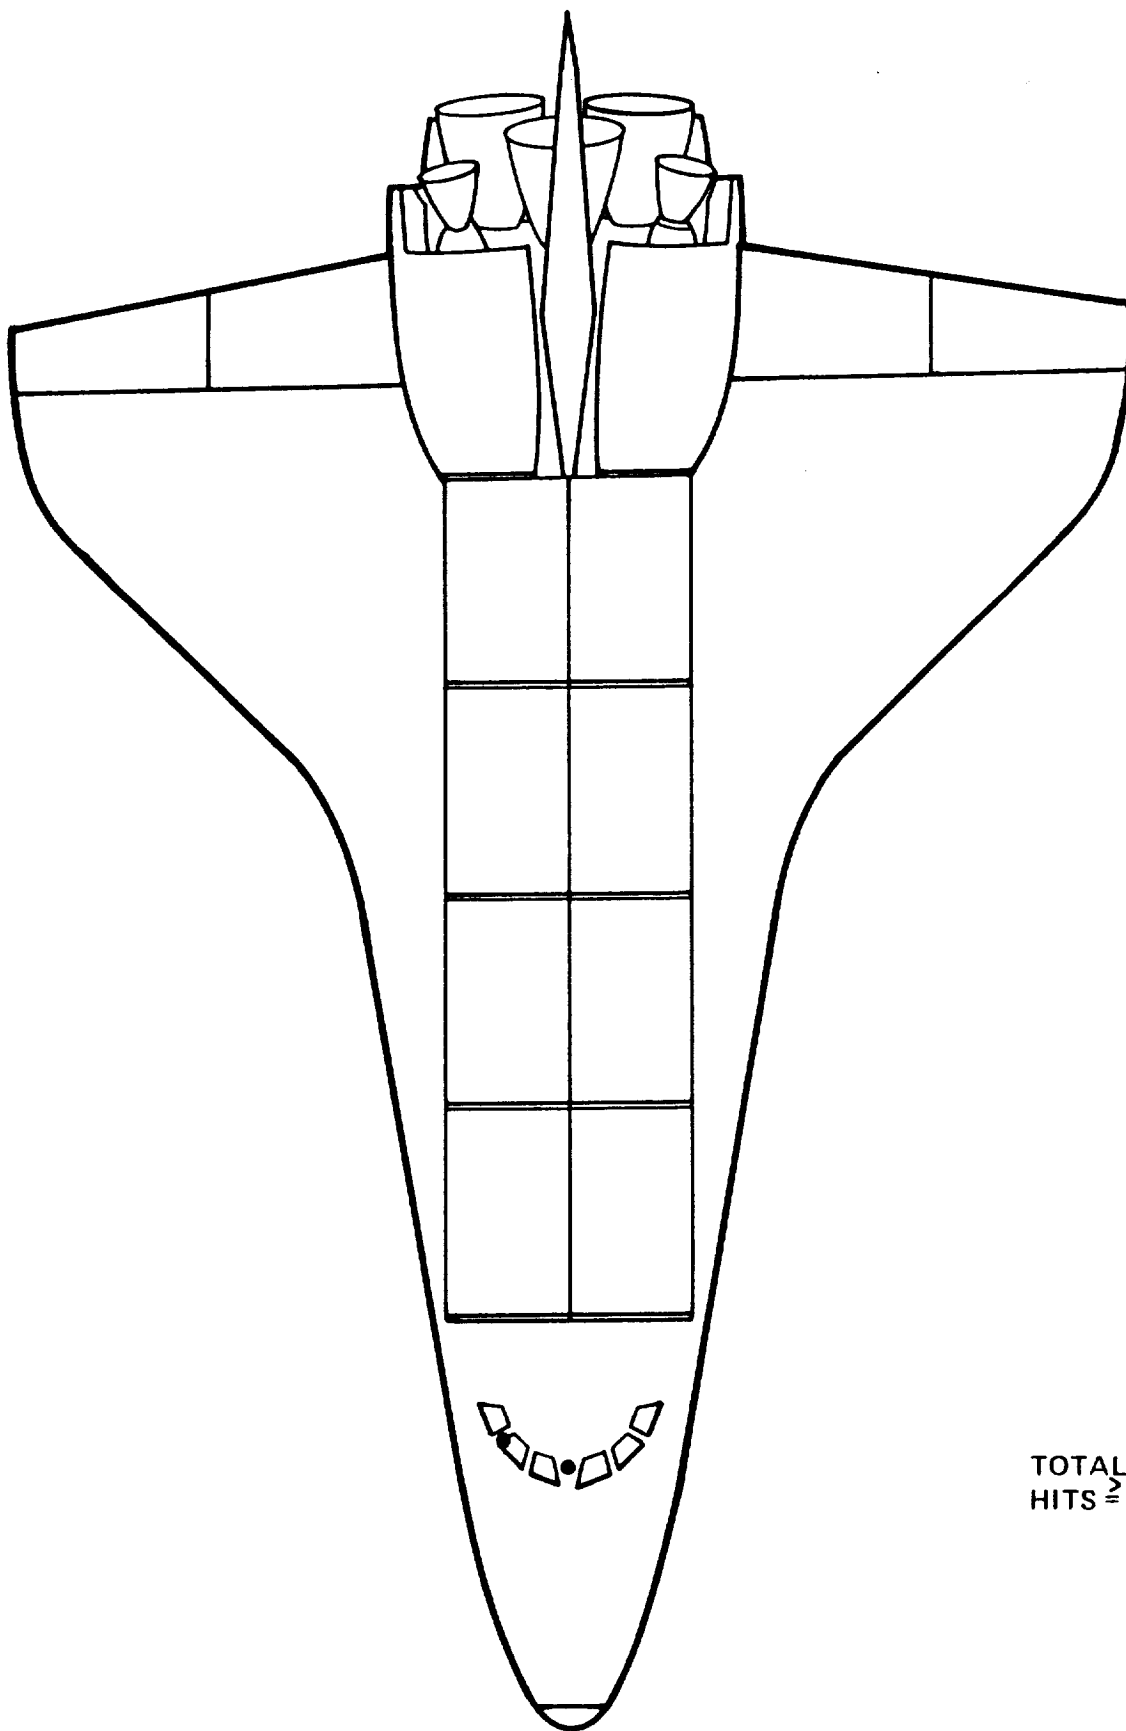
FIGURE 18. **STS-43**
DEBRIS DAMAGE LOCATIONS

A cluster of 19 hits (with 7 larger than one inch) occurred just forward of the LO2 ET/Orbiter umbilical. Similar clusters of hits have been observed in this area on previous flights and may be attributed to ice from the LO2 feedline bellows or support brackets. A second cluster of 12 hits (with 4 larger than one inch) occurred just aft of the LO2 ET/ORB umbilical cavity and may be attributed to ice from the LO2 ET/ORB umbilical during ET separation and/or damage from purge barrier baggie and ice during ascent.

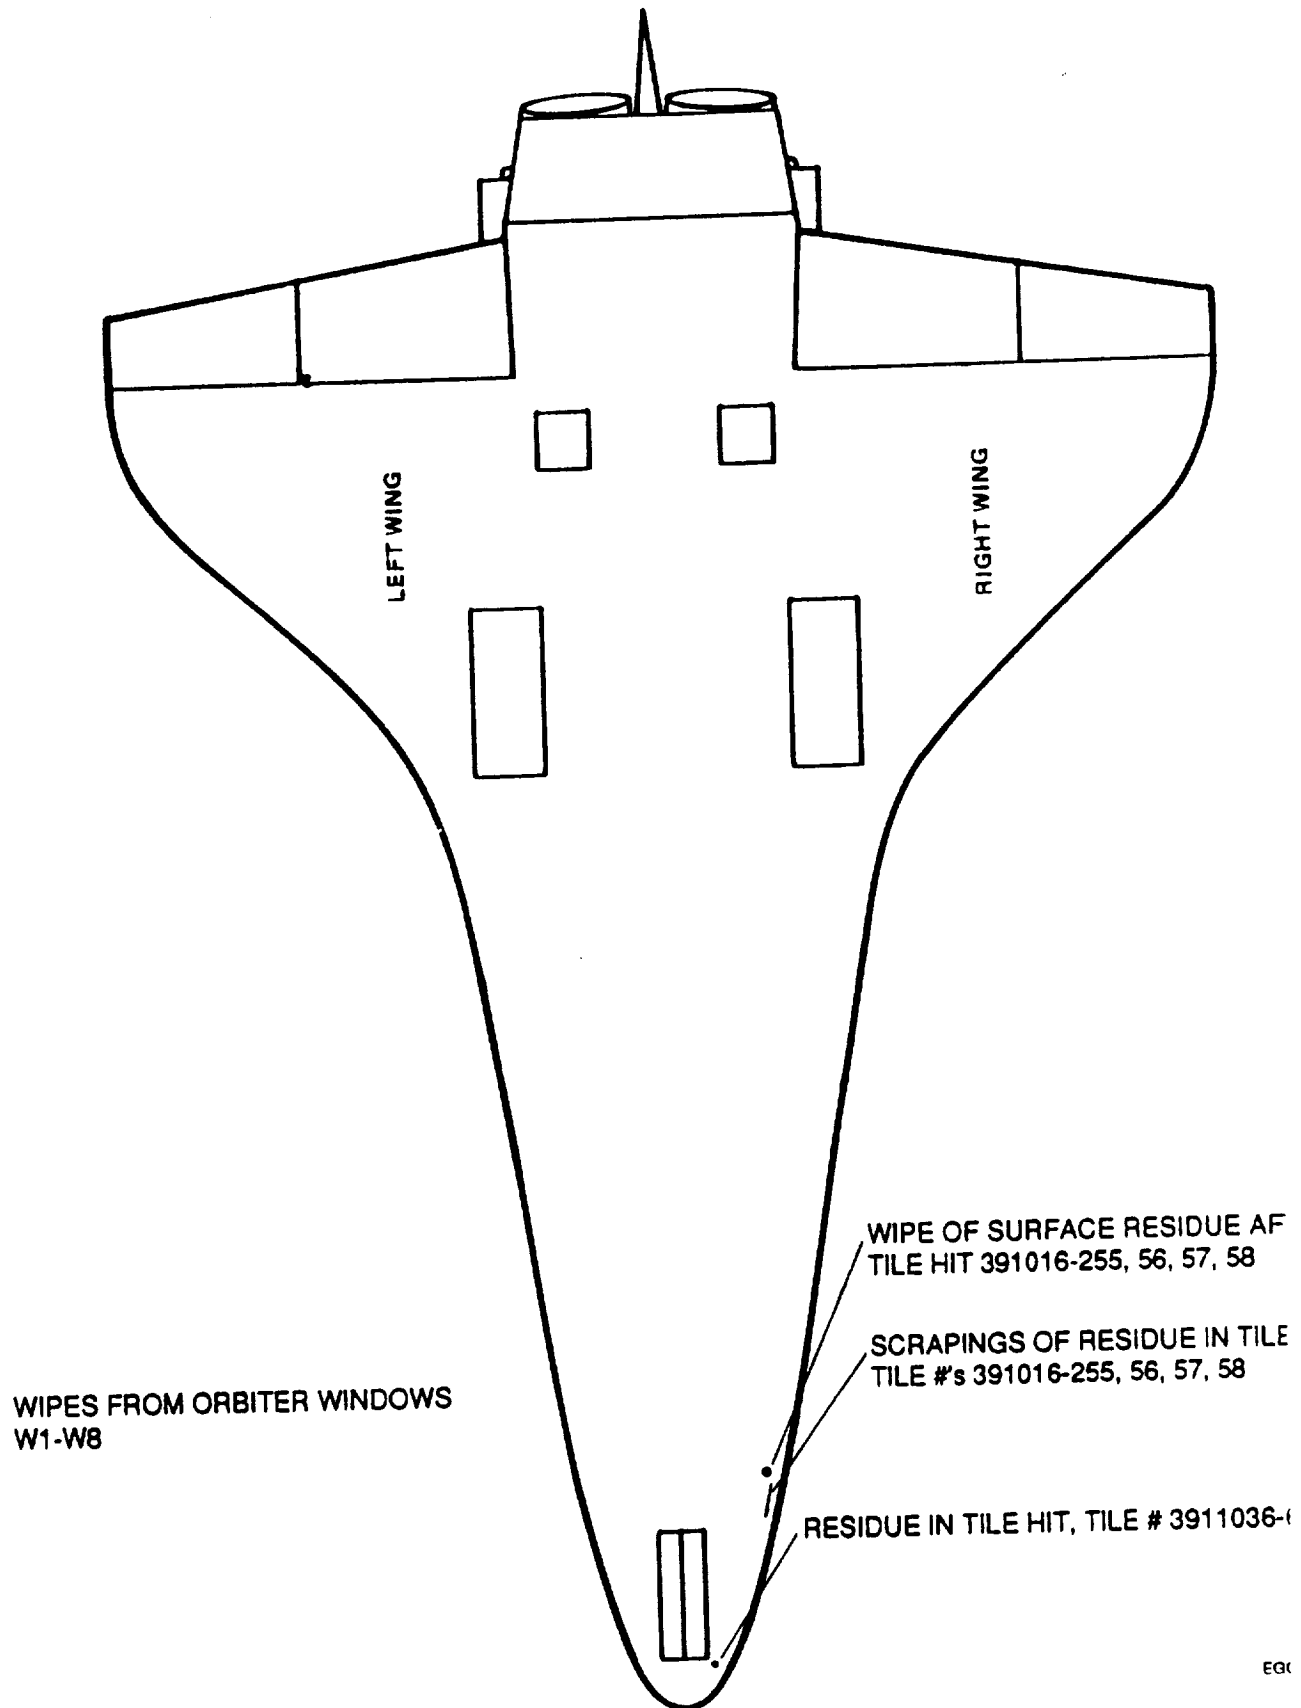
FIGURE 19. **STS-43**
CHEMICAL SAMPLE LOCATIONS

Orbiter windows #3 and #4 exhibited moderate to heavy hazing with a few small streaks. Windows #1, #2, #5, and #6 had light to moderate hazing with several small streaks. There was no evidence that the haze on the windows was the result of flight through volcanic ash. Figure 19 shows the sites on the Orbiter where samples were taken for laboratory analysis.

A total of 12 samples were obtained from Orbiter OV-104 during the STS-43 post landing debris assessment at Kennedy Space Center, Florida (Figure 19). The 12 submitted samples consisted of 8 Orbiter window wipes (W1-8), 3 tile residue samples, and 1 debris sample from the runway. The samples were analyzed by the NASA KSC Microchemical Analysis Branch (MAB) for material composition and comparison to known STS materials. The specific elemental analysis is shown in the appended MAB report. Debris analysis involves the placing and correlating of particles with respect to composition, thermal (mission) effects, and availability. Debris sample results and analyses are listed by Orbiter location in the following summaries.

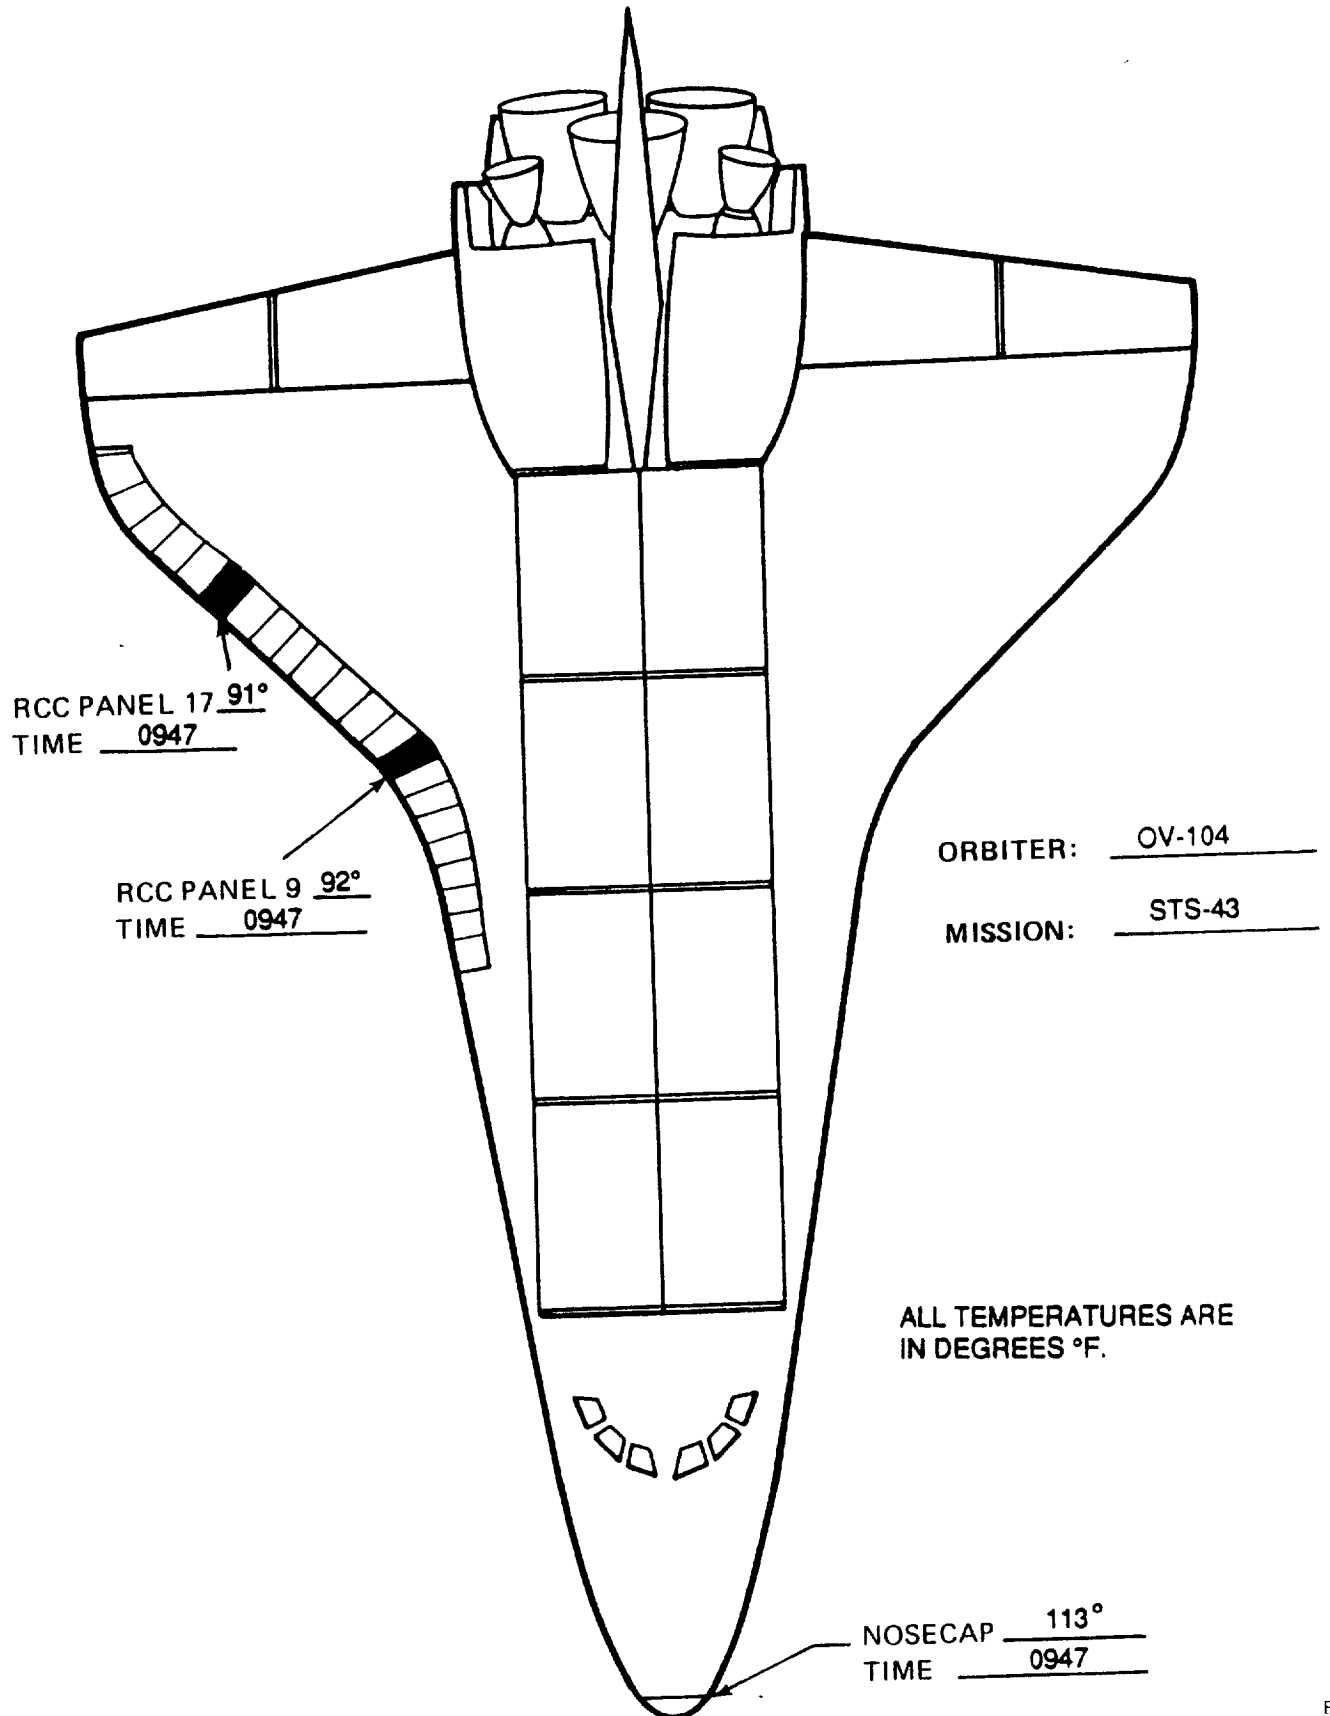
FIGURE 20. **STS-43**
TEMPERATURE MEASUREMENTS

The Mikron infrared radiometer was used to measure the surface temperatures of several areas on the Orbiter. Eighty-four minutes after landing, the nosecap RCC was 113 degrees F, the RH wing leading edge RCC panel #9 was 92 degrees F, and the RH wing panel #17 was 91 degrees F (Figure 20).

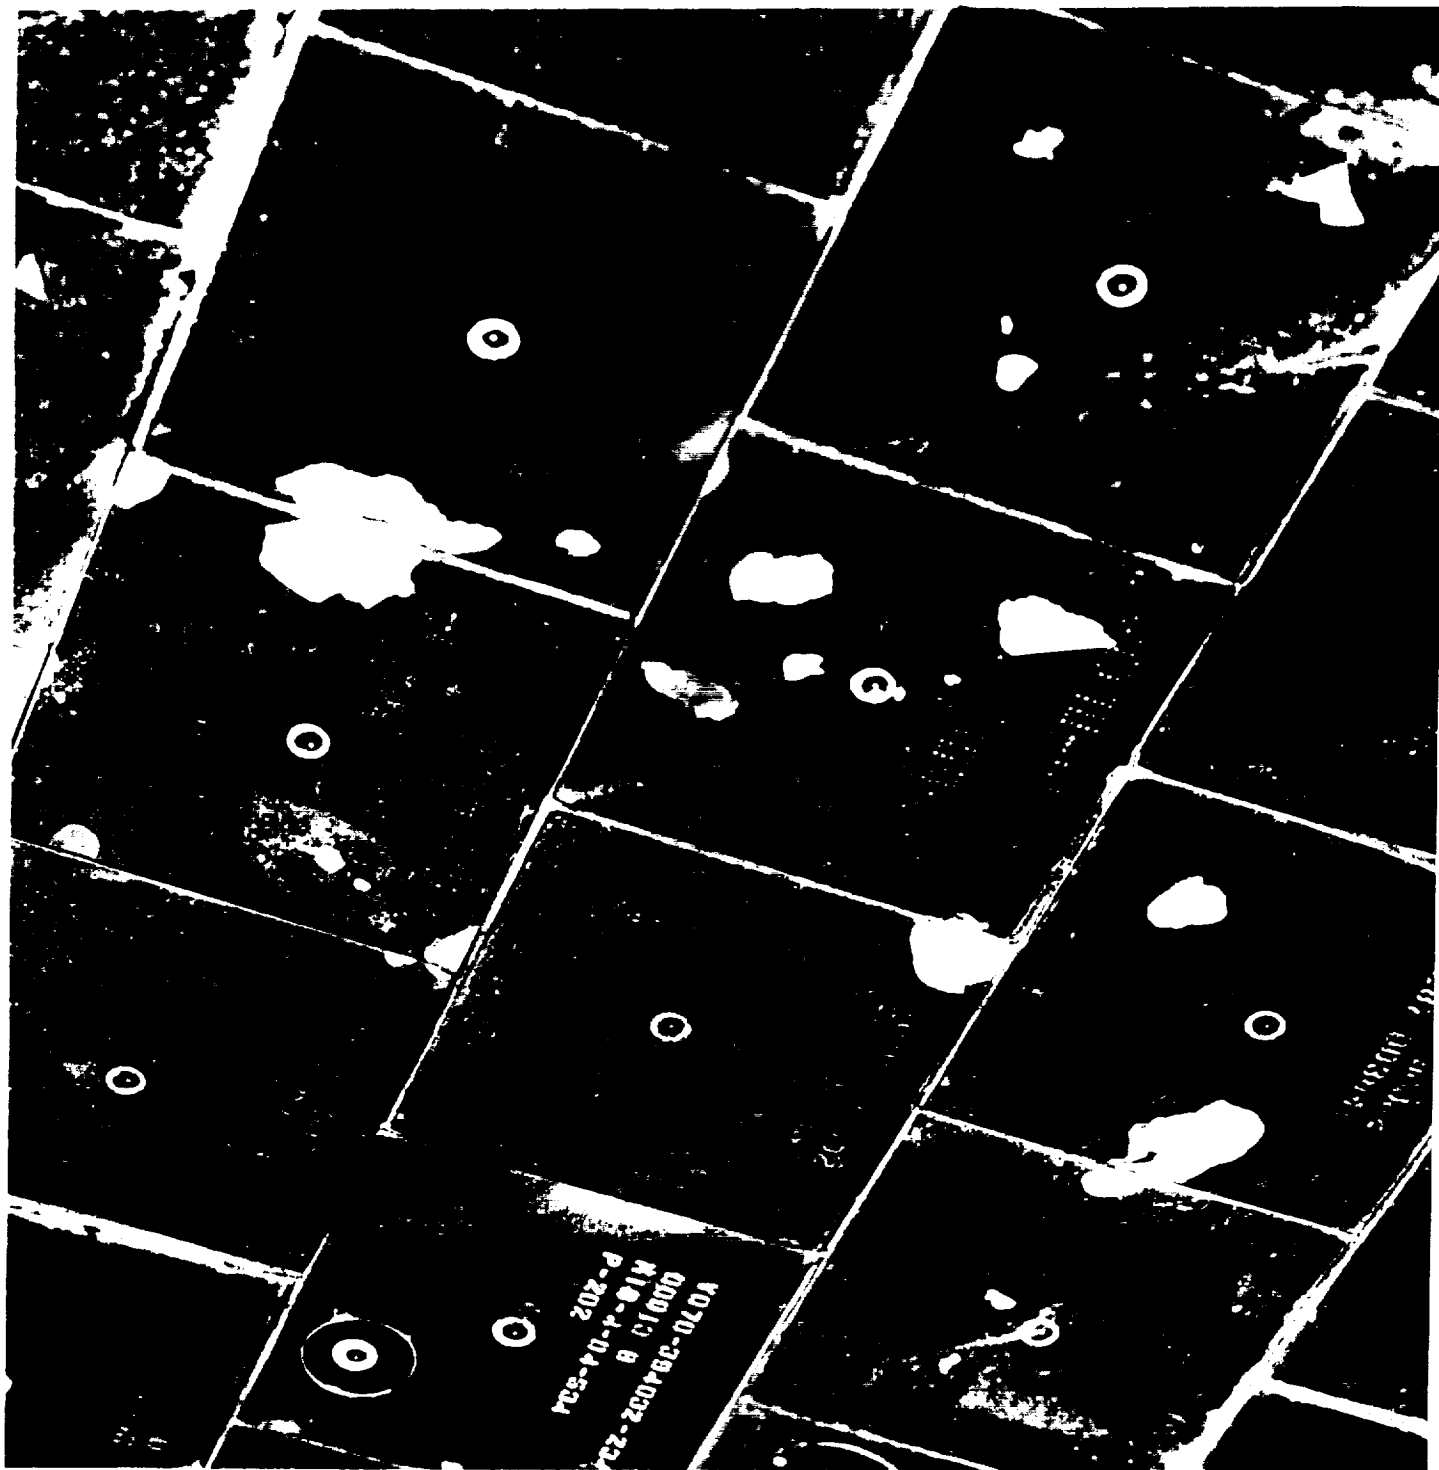
Similar tile damage have been observed forward of the L02 ET/ORB umbilical on previous flights and may be attributed to ice from the L02 feedline bellows and support brackets.

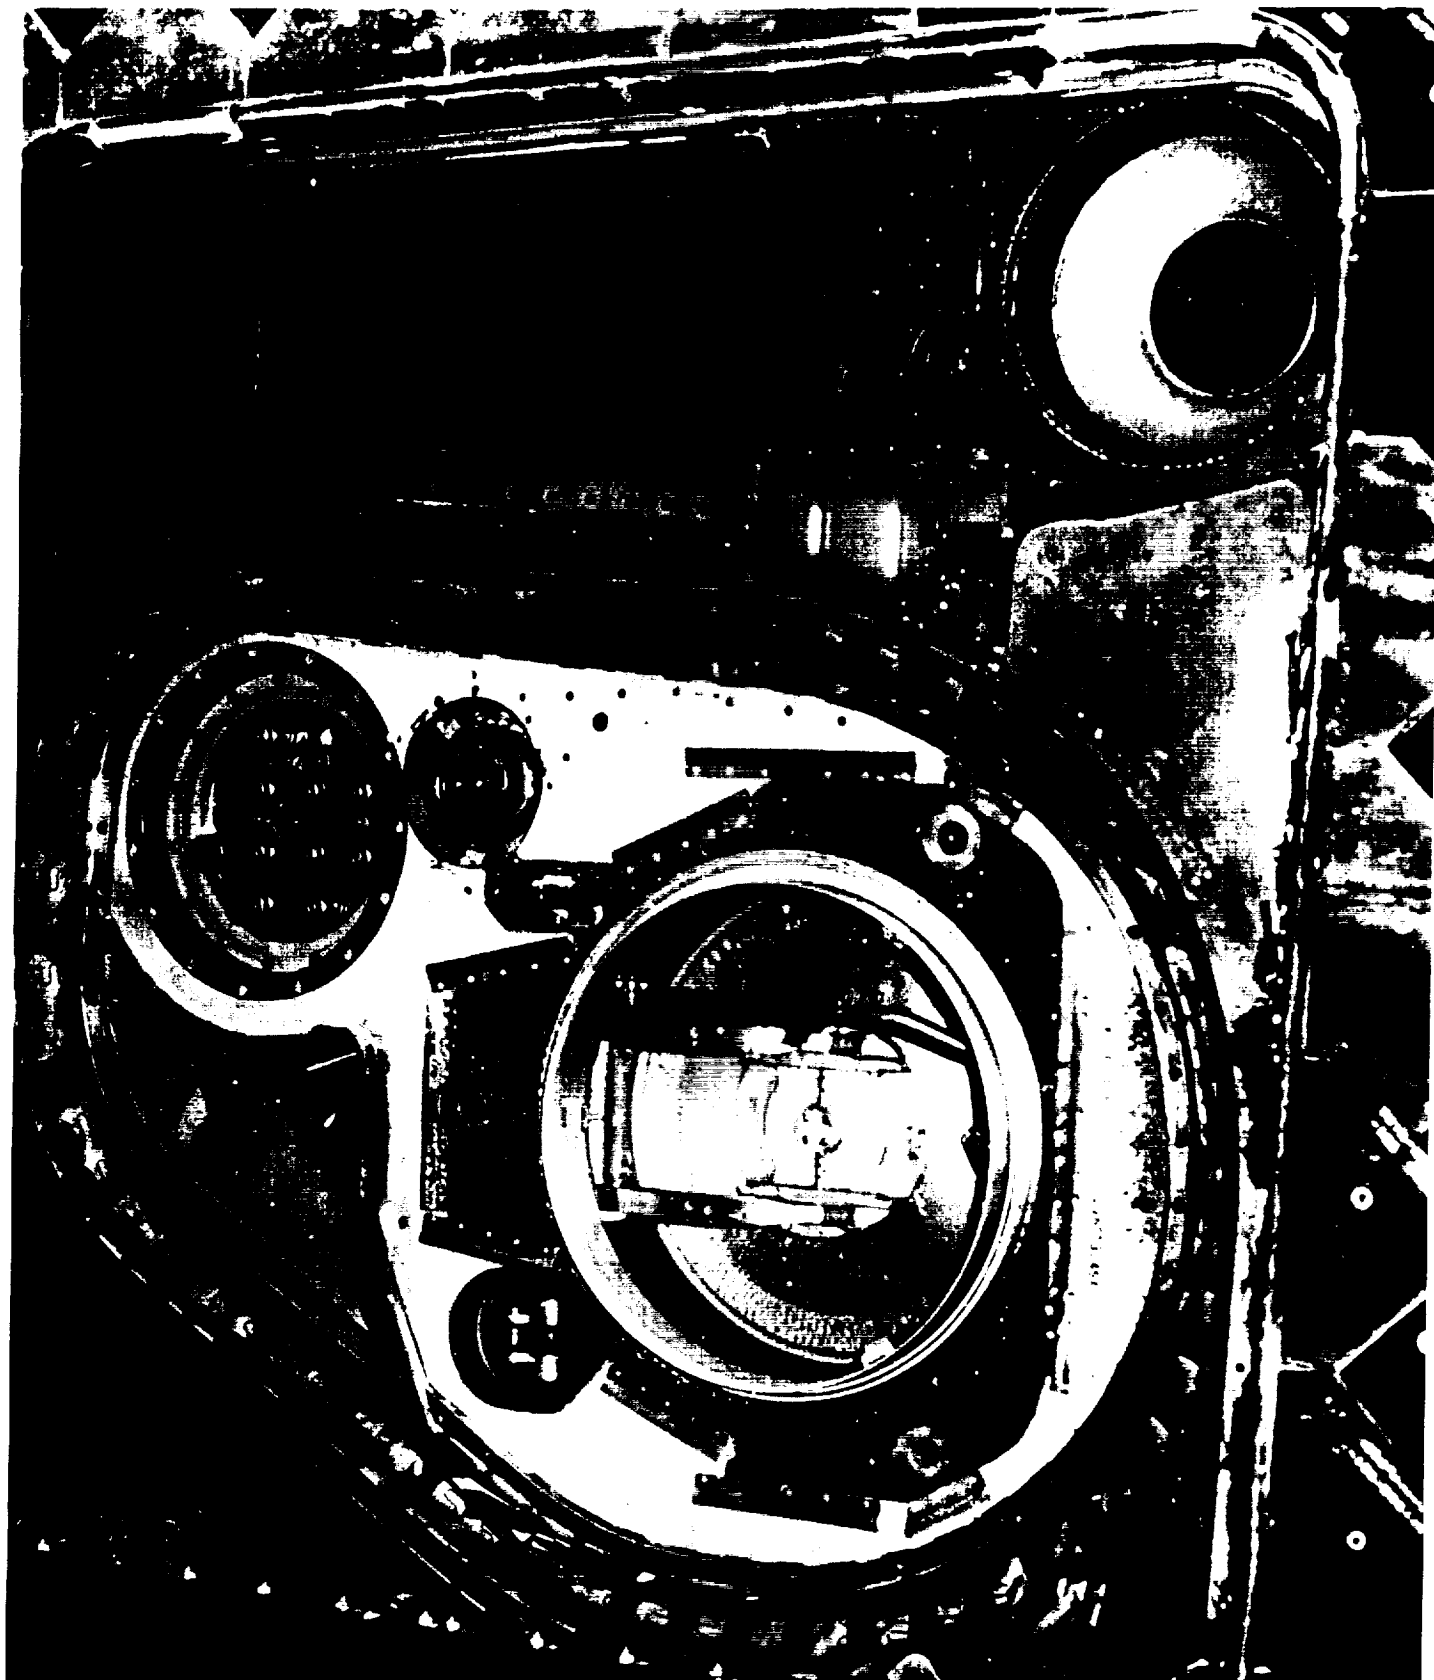
Overall view of the L02 ET/ORB umbilical. The separation ordnance device debris plunger in EO-3 was seated and appeared to have functioned properly. There was no significant heat intrusion past the ET door thermal barrier.

A metallic U-shaped object, identified as a V072-565471-001 yoke, was found on the runway beneath the LO2 ET/ORB umbilical and originated from the forward inboard umbilical separation bolt head.

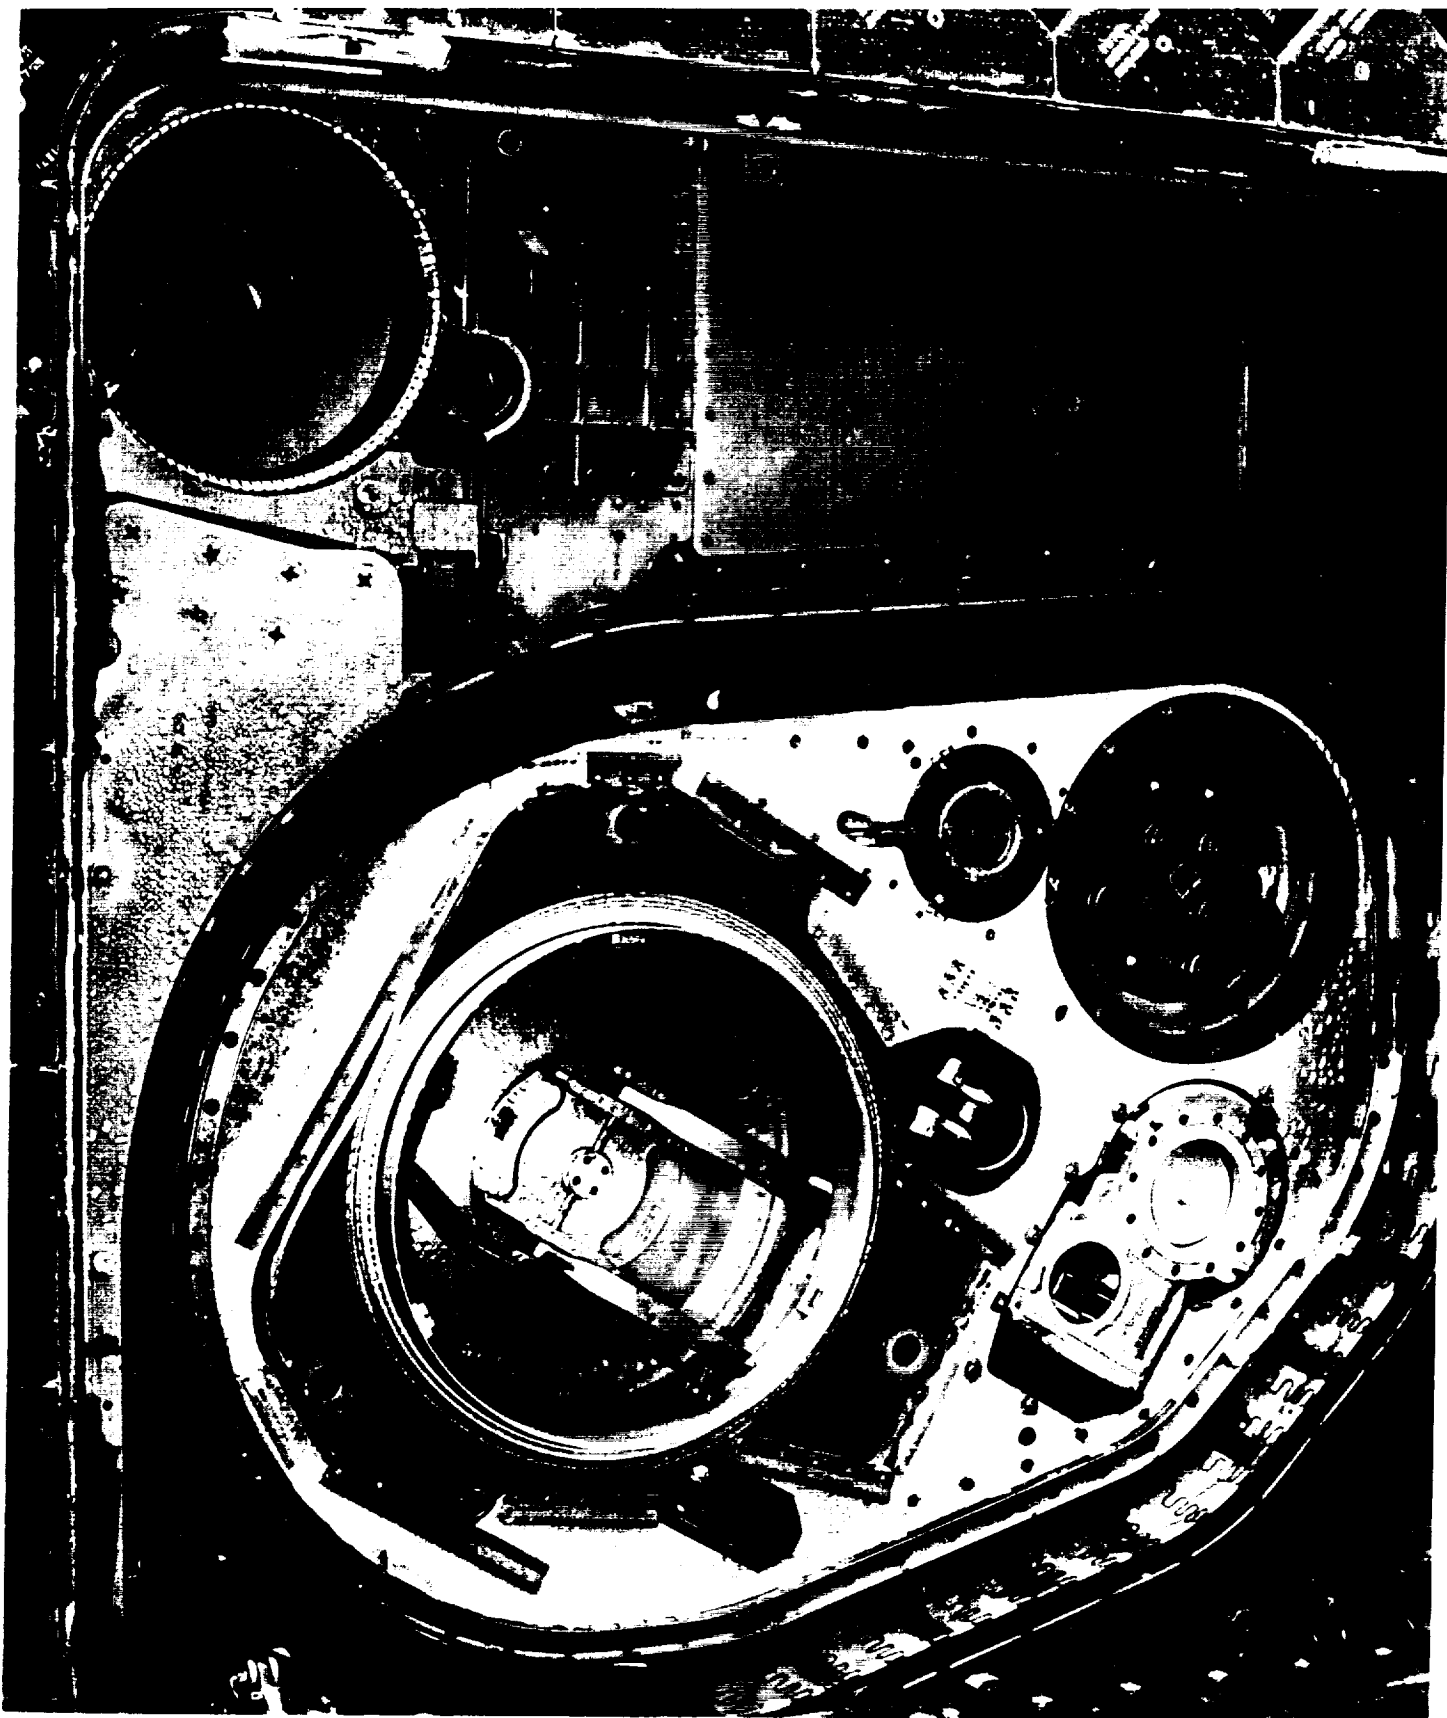
Overall view of the LH2 ET/ORB umbilical. The separation ordnance device debris plunger in EO-2 was seated and appeared to have functioned properly. There was no significant heat intrusion past the ET door thermal barrier.
